UNITED STATES DEPARTMENT OF THE INTERIOR  
NATIONAL PARK SERVICE**NATIONAL REGISTER OF HISTORIC PLACES  
INVENTORY -- NOMINATION FORM**

Yakima Park Stockade Group

North and South Blockhouses, Museum, and Stockade at Sunrise

Mount Rainier National Park

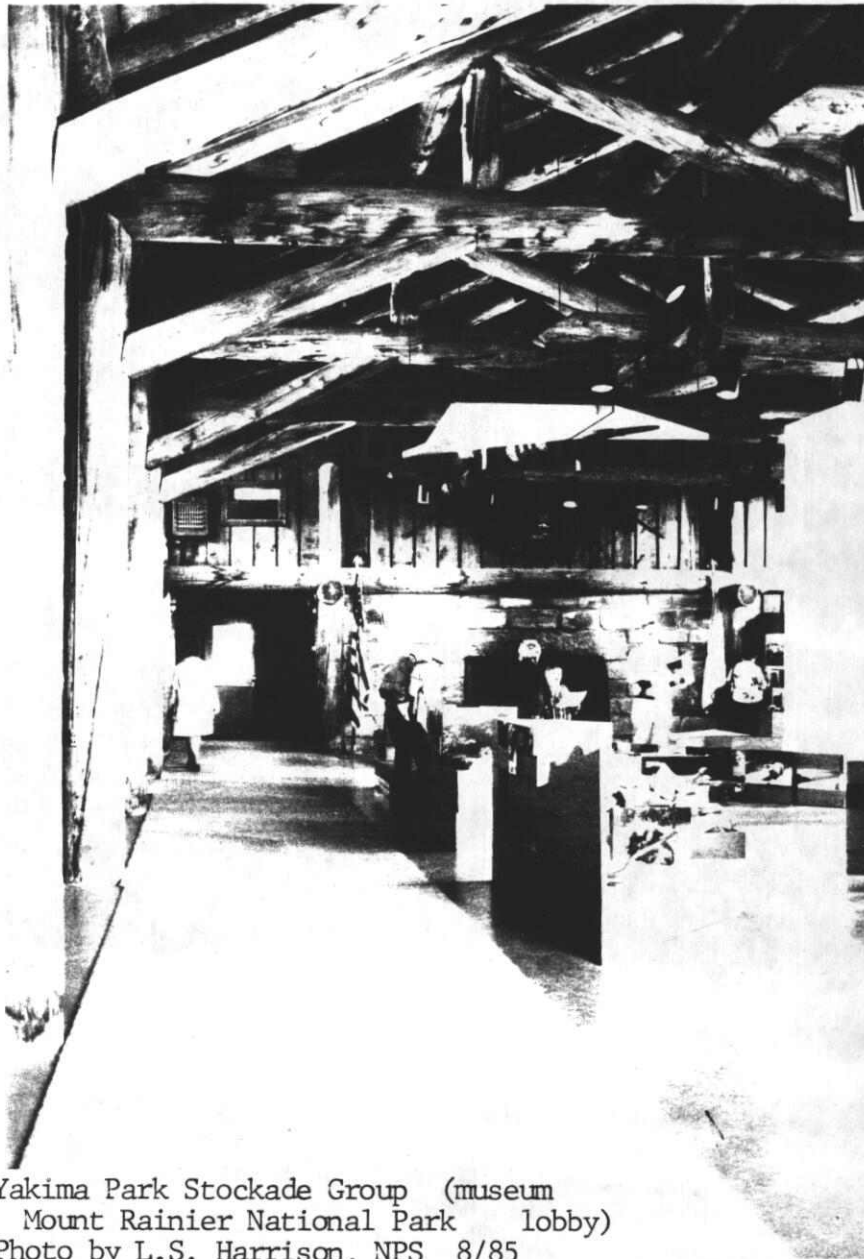
Yakima Park Stockade Group (museum  
Mount Rainier National Park lobby)  
Photo by L.S. Harrison, NPS 8/85

The exposed roof structure of logs and rough-cut decking provides a rugged appearance on the interior. The pratt-truss logwork supports the roof purlins and rafters above. The trusswork is reinforced with tie rods, undoubtedly necessary because of the heavy snow loads. New spotlights have been attached to the historic fabric on the interior to highlight the interpretive exhibits. Some appear to be placed where original lights were. Suspended acoustical panels were also added to cut down on interior noise. Interior walls are the exposed logs. On a sunny day the most used portion of the room is the south end which is outfitted with a telescope through which a viewer can see parties climbing the northwest slopes of Mount Rainier. At the north end of the main room is an enormous coursed rubble fireplace, added in 1952. The fireplace opening is approximately 4.5x6 feet and holds simple andirons. Behind the fireplace at the north end of the building are two levels of office and storage space, the partitions of which appear to have been moved several times. The new floor of the main room is wood boards laid diagonally.
